PRECISION™ SERIES SPRAY NOZZLES

Independent, 3rd Party Test Data Supporting The Conclusion That Toro Precision Series Spray Nozzles Deliver Distribution Uniformity Greater Than Or Equal To All Rotating Nozzles Currently Rebated By Metropolitan Water District

Toro Irrigation
5825 Jasmine Street
Riverside, CA 92504
August 2009

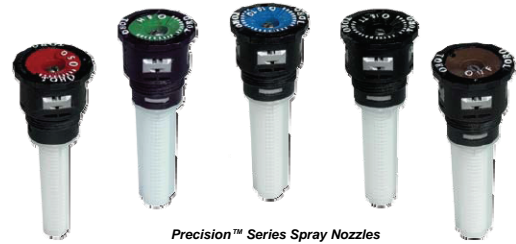
Toro Precision Series Spray Radius and Distribution Test Procedure

1. Mount the nozzle on a riser located approximately 4" above the plane of the catch cans. Alternatively, mount the nozzle on a 4" sprinkler level with the plane of the catch cans.
2. Align the left arc edge of the nozzle with the edge of the catch can grid if applicable.
3. Manually start test fixture at 30 PSI, inlet.
4. Adjust the nozzle orientation to capture the desired arc of spray (center the spray over the collectors).
5. Allow the sprinkler to run at 30 PSI for a minimum of 15 minutes or until a catch can is filled to capacity.

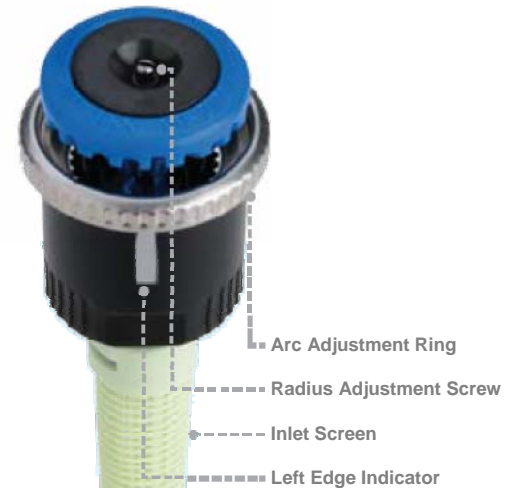
MP Rotator Radius and Distribution Test Procedure – 180 Degree Arc

I. Setting the Arc – Maximum Radius

1. Mount the nozzle on a riser located approximately 4” above the plane of the catch cans. Alternatively, mount the nozzle on a 4” sprinkler level with the plane of the catch cans.
2. Align the left arc edge of the nozzle with the edge of the catch can grid.
3. Verify radius adjustment screw is backed out fully – not restricting flow.
4. Set the arc to the approximate desired angle (180 degrees).
5. Manually start test fixture at 40 PSI, do not collect the water or resulting data from manual operation.
6. Adjust arc adjustment ring clockwise to increase arc (flow) or counterclockwise to decrease arc (flow) in order to achieve specified flow rate per catalog (see catalog sheet Reference H-01 attached).
 - MP1000 – 0.37 GPM (14’ radius)
 - MP2000 – 0.74 GPM (19’ radius)
